## TECHNICAL FEATURE

# Controlling Condensation On CWP Insulation

BY ED LIGHT, MEMBER ASHRAE; JAMES BAILEY, P.E., MEMBER ASHRAE; AND ROGER GAY

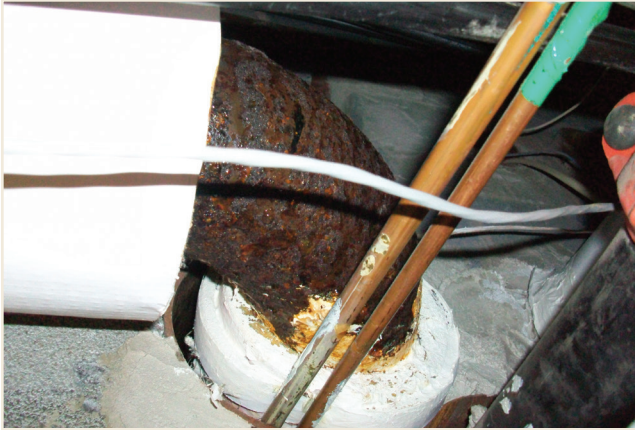
PHOTO 1 Pipe section left unsealed.

Condensation forms where insulation is missing or insufficient, or vapor barriers are not fully sealed (*Photos*

*1* and *2*). Condensation wets the insulation and this moisture can wick through fibrous pipe insulation for considerable distances. During the construction process, new insulation is often not inspected closely and thus, insulating deficiencies are often not repaired. As the building ages, insulation deteriorates and/or also can be damaged during repair work by maintenance personnel or renovation by contractors.

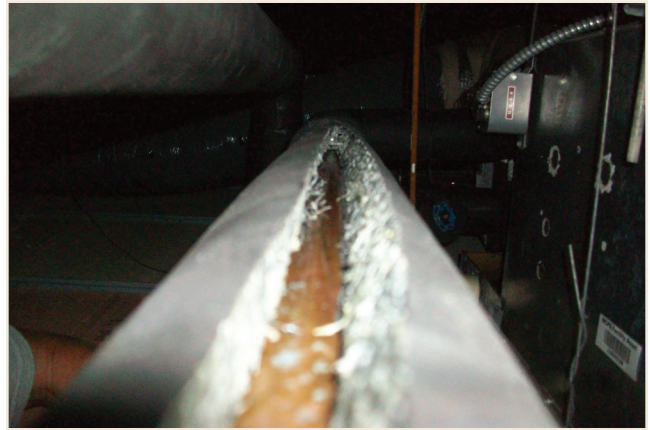
PHOTO 2 Insulator failed to seal top seam.

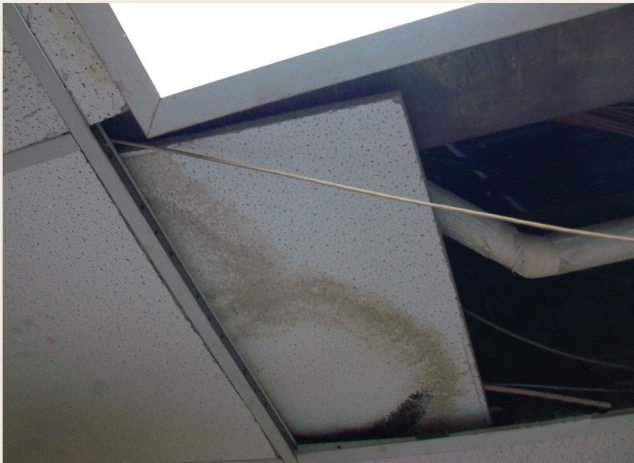
PHOTO 3 Stained ceiling tile under sweating chilled water pipe.

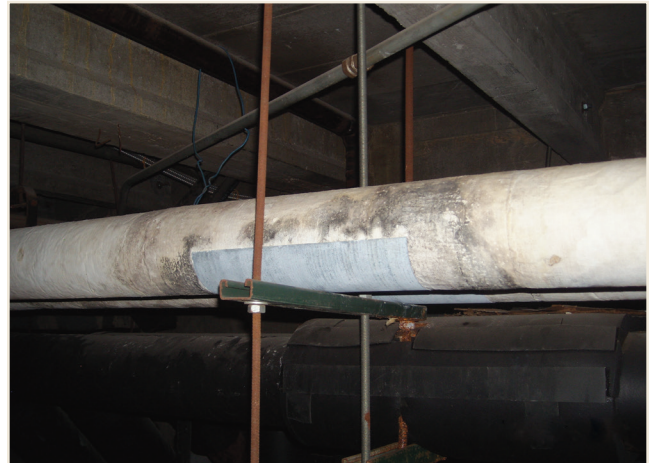
PHOTO 4 Major water damage.

The condition of CWP insulation with respect to condensation control can be assessed visually, by identifying insulation deficiencies and noting the relative severity and extent of water damage. Examples of staining patterns considered minor and major are illustrated in *Photos 4* and *5*. Suspect growth is often present in areas with major condensation. Where suspect spotting is not associated with water stains on the insulation—the root cause may be excessive space humidity—not insulating deficiencies (*Photo 6*).

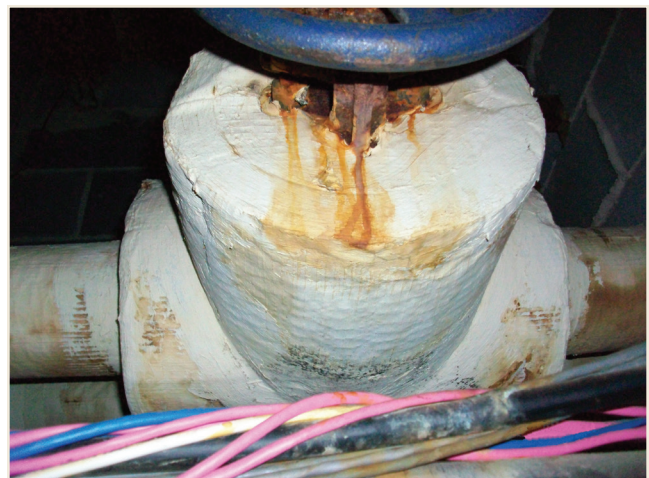
PHOTO 5 Minor water damage.

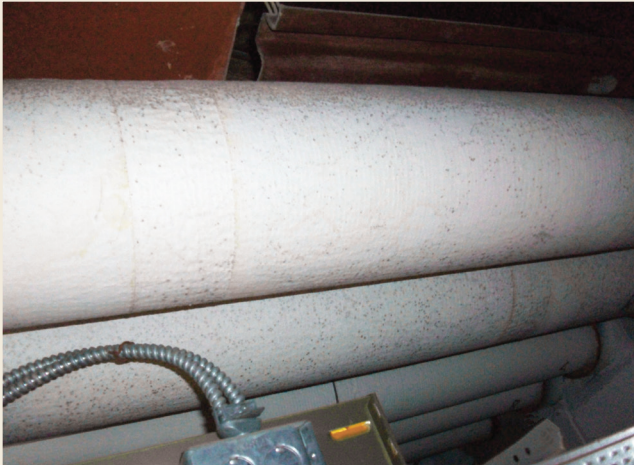
PHOTO 6 Mold spotting caused by excessive humidity.

In some areas, the underlying cause of suspect spotting on CWP insulation is not defective workmanship, but excessive space humidity. Improved humidity control is needed to protect CWP insulation in these areas.

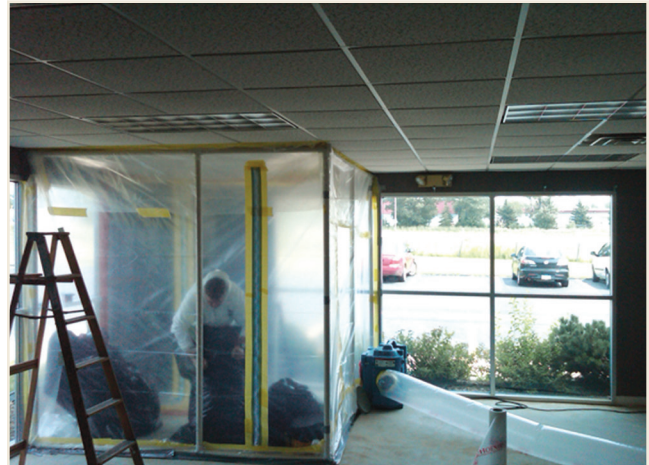
PHOTO 7 Insulation removal following hazardous material procedure.

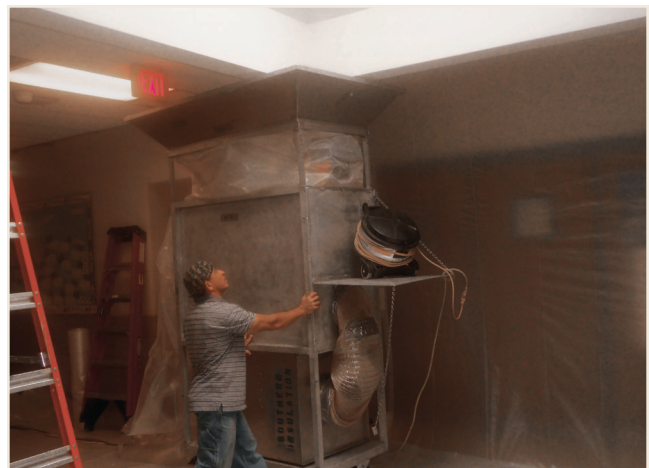
An alternative method for remediating mold-contaminated CWP insulation replaces full containment with local exhaust ventilation. Insulation is removed over a portable hood and underlying surfaces are covered with plastic sheeting. The ventilation unit consists of an inverted exhaust hood atop an aluminum portable rolling containment, with a HEPA-filtered exhaust system. Height of the hood is adjustable and it is set just below the piping (*Photo 8*).

PHOTO 8 Insulation removal using portable hood.

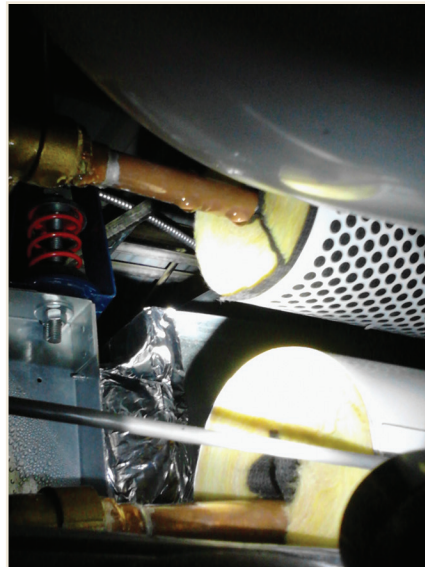
In contrast, major condensation associated with vapor barrier defects was observed from insulation installed without enhanced QC measures (*Photo 9*).

PHOTO 9 Incomplete insulation installed without enhanced quality control.
